ROOF ASSESSMENT REPORT

**MONTAGUE TOWN POLICE DEPARTMENT
180 TURNPIKE ROAD
TURNER FALLS, MA 01376**

Date: March 15, 2022
NRC Project No. 22-001

RE: Roofing Consulting Services
Roof Assessment and Report
Montague Town Police Department
Turners Falls, MA

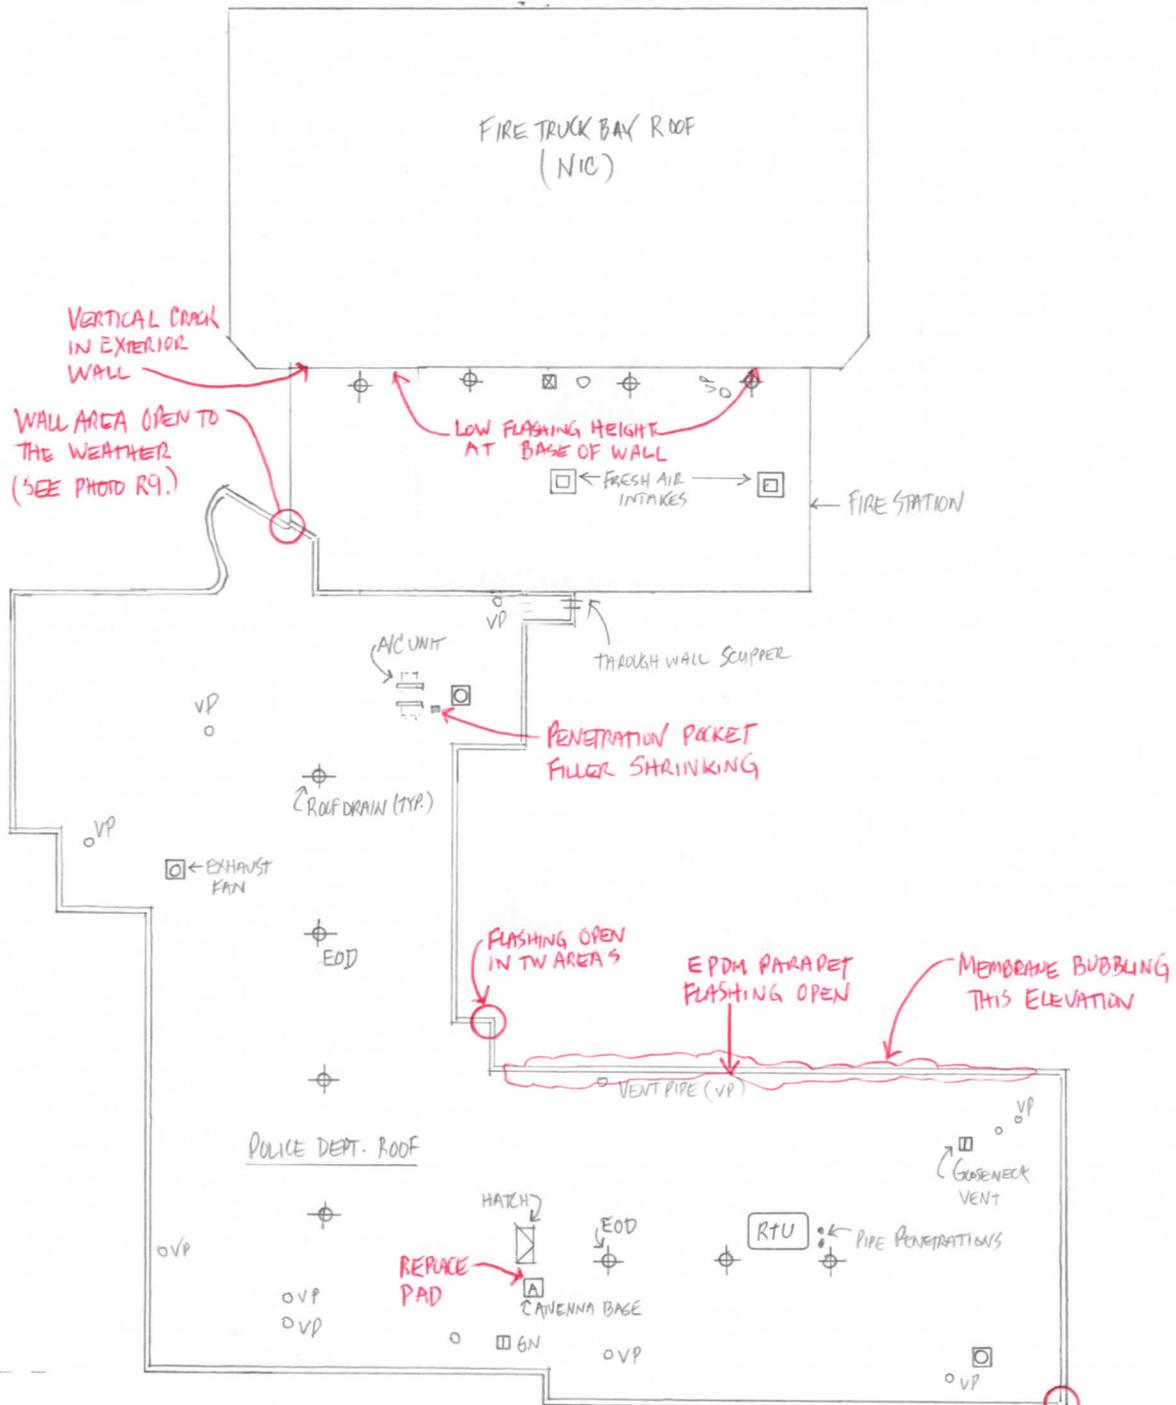
SK-1

MEMBRANE AT INSIDE CORNER DELAMINATING

- Re-adhere open seams in the low parapet flashing at locations indicated on the roof sketch. **(This work should be covered under the existing warranty.)**
- Replace or add pourable sealant at the penetration pocket indicated on the roof sketch.
- Replace the buffer pad under the roof antenna base with a new pad approved by the membrane manufacturer.
- Properly seal the exposed reinforcing mesh in the wall system and adjacent opening in the wall with appropriate materials.
- Clean roof and drain basket of debris.
- Rout and seal the vertical crack in the vertical wall above the Fire Department low roof with appropriated materials.
- **Cost Estimate for work not covered under the roof membrane manufacturer's warranty- \$1,000 - \$2,000 (Based on 2022 Costs).**

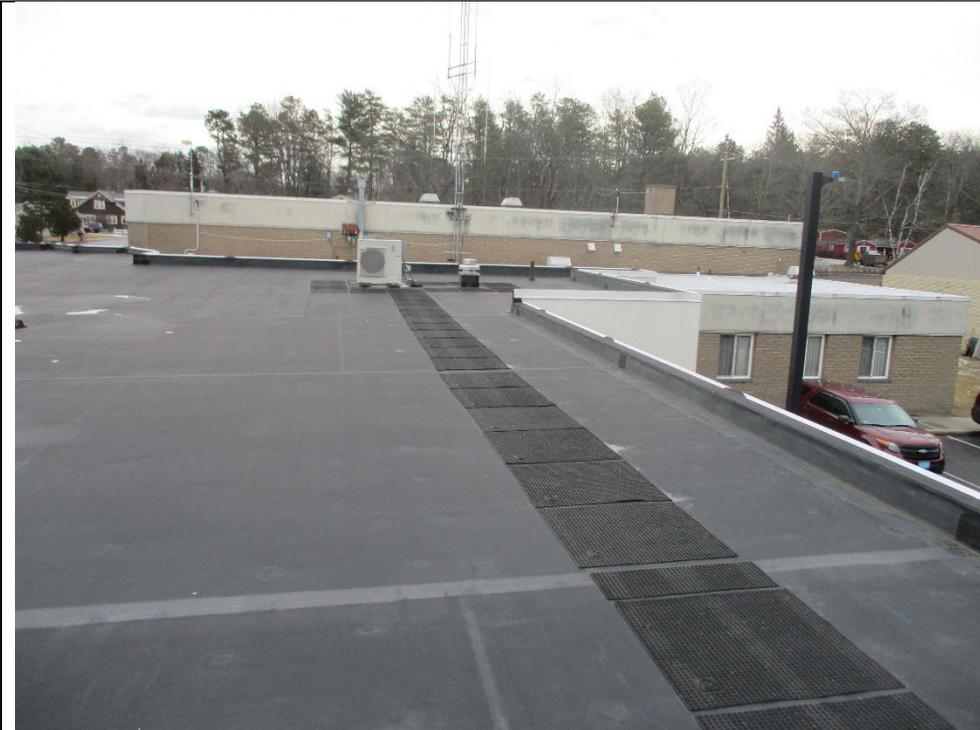
Photo R1
02/17/22

Description:
View of the
adhered EPDM
roofing system over
the Police
Department Facility
looking west to
east.

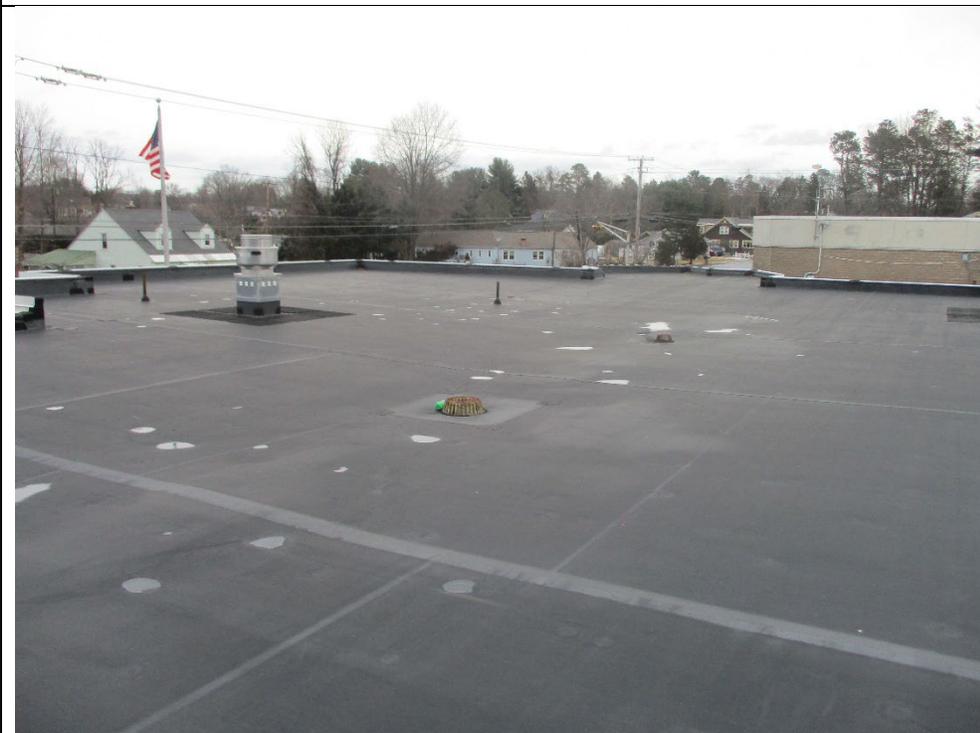
Photo R2
02/17/22

Description:
View of the
adhered EPDM
roofing system over
the Police
Department Facility
looking west to
east.

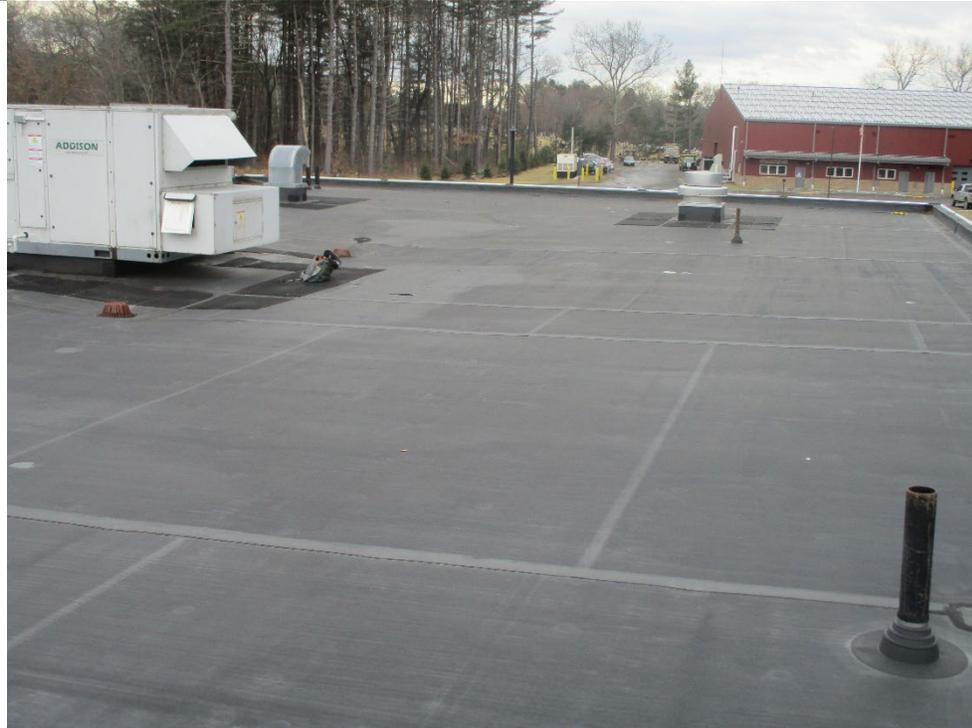
Photo R3
02/17/22

Description:
View of the
adhered EPDM
roofing system over
the Police
Department Facility
looking north to
south.

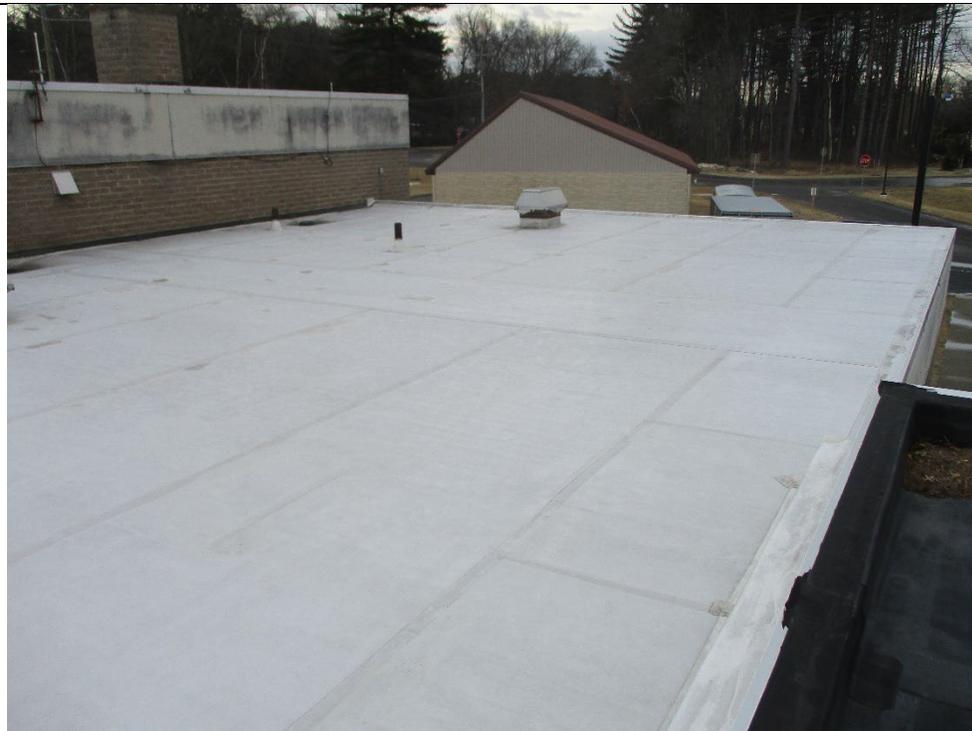
Photo R4
02/17/22

Description:
View of the
adhered TPO
roofing system over
the Fire
Department Facility
looking north to
south.

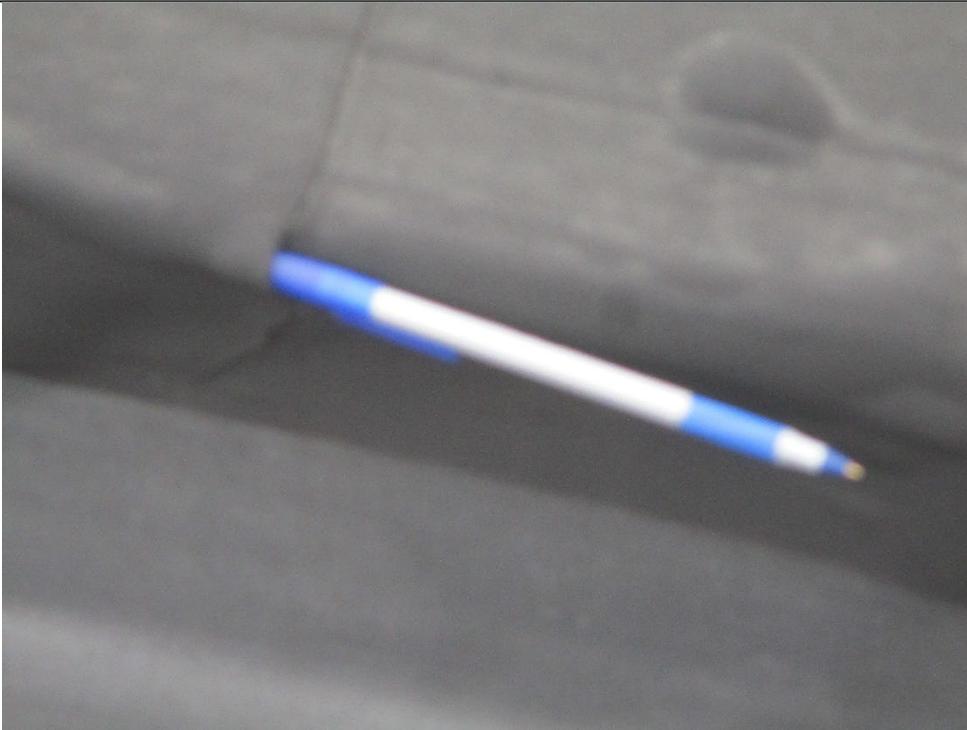
Photo R5
02/17/22

- The EPDM perimeter flashing is delaminating at several of the parapet inside corners and at the top of the low parapet.
- The EPDM membrane on the inside face and top of the perimeter parapet is unadhered and bubbling along the east elevation of the roof. The bubbling is typically caused by sealing of the membrane while the adhesive/primer is wet or when adhering the membrane when the temperatures are below 40 degrees F.
- The sealant at the pourable sealer pockets is aged, dried and shrinking. Voids in the sealant may allow water to enter the building interior.
- The protection pad between the antenna base and surface of the EPDM membrane is deteriorated and in need of replacement.
- Pine needles and other debris is collecting on different areas of the roof.

Description:
Void in EPDM
flashing at low
parapet at seam
overlap.

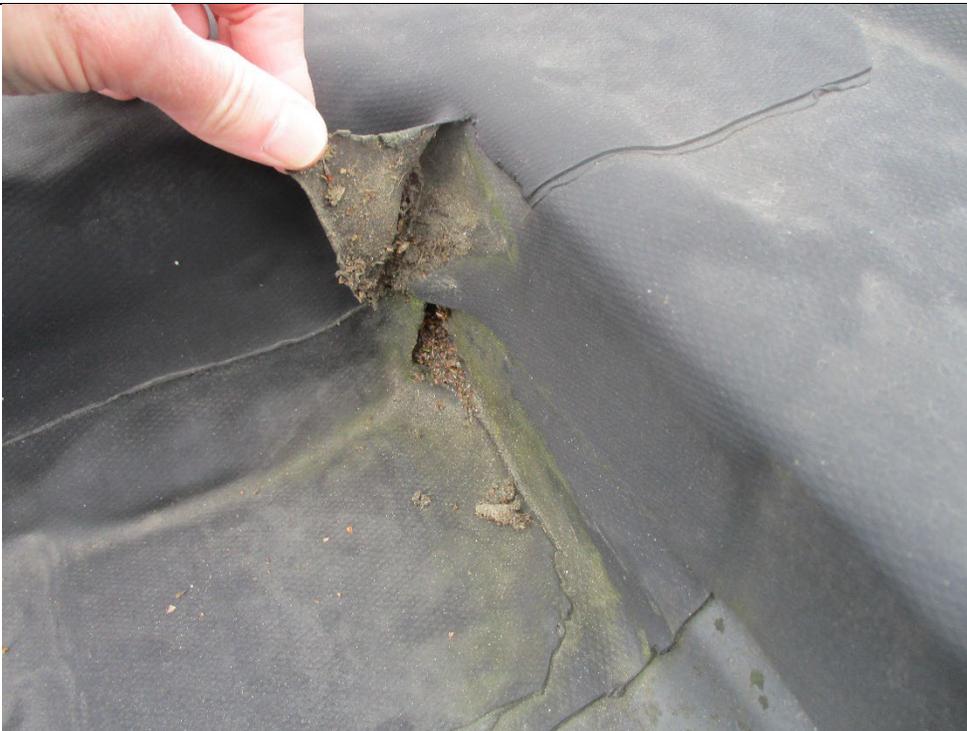
Photo R6
02/17/22

Description:
Opening in EPDM
flashings at inside
corner of low
parapet.

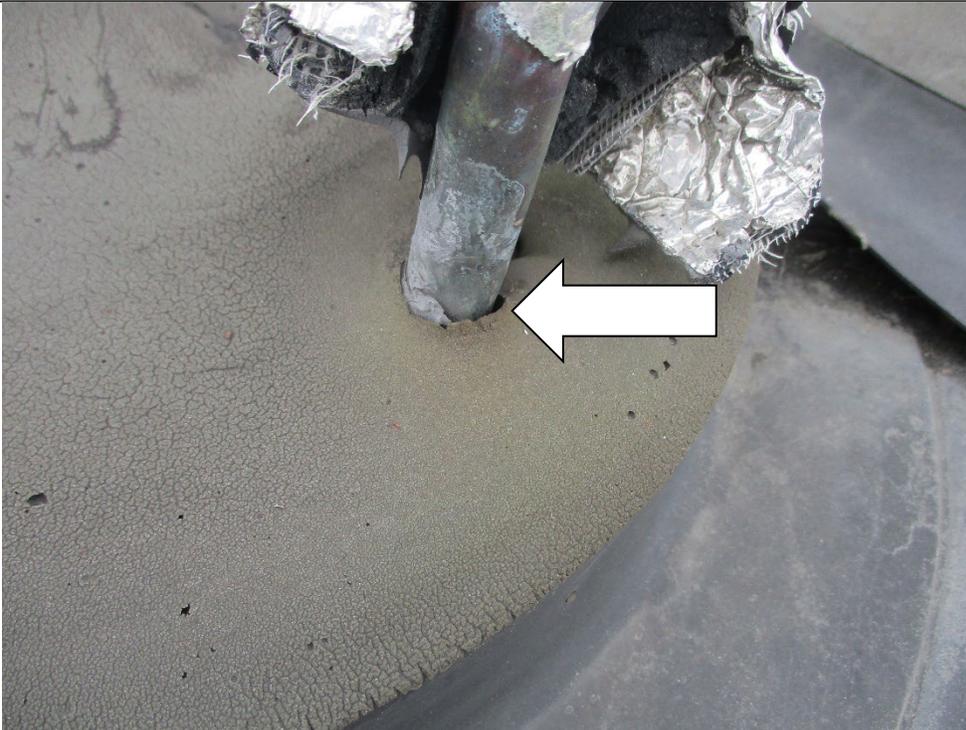
Photo R7
02/17/22

Description:
Shrinking of
penetration pocket
sealer pulls away
from copper pipe
and allows
moisture into the
building.

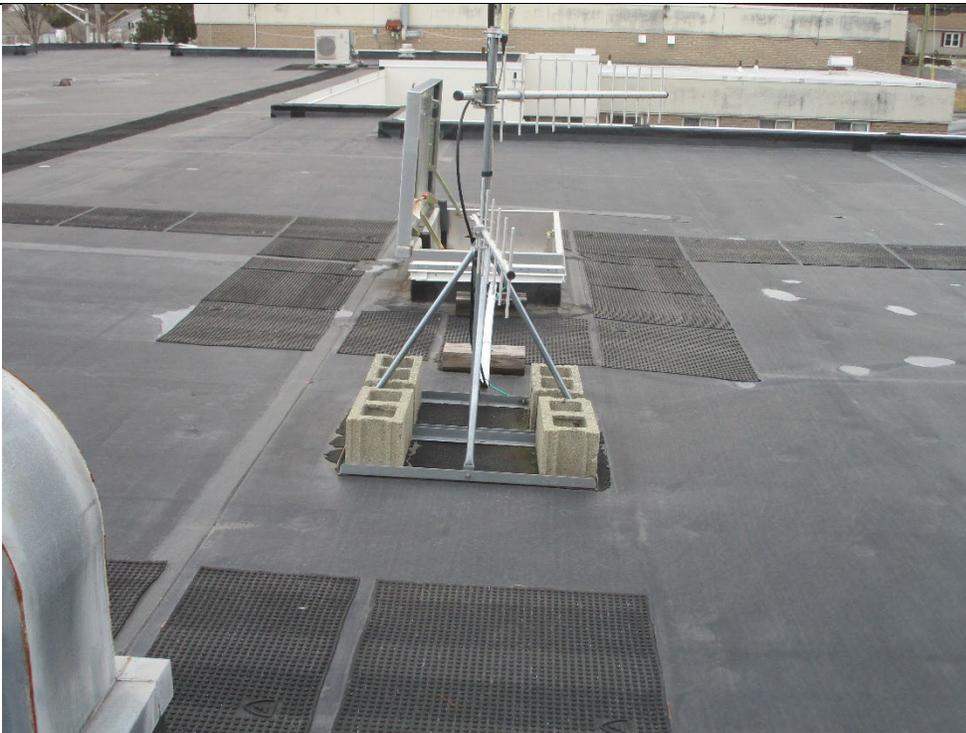
Photo R8
02/17/22

Description:
Pad under antenna
base is deteriorated
and requires
replacement.

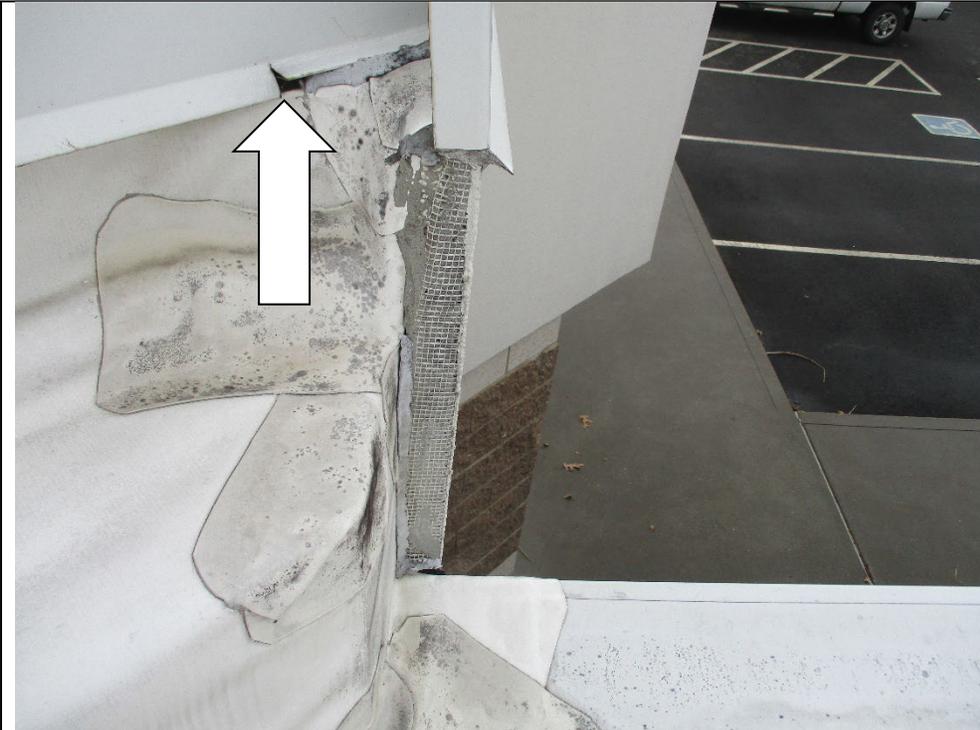
Photo R9
02/17/22

- Minor areas of standing water were evident on the roof surface during the assessment.
- The outside corner of the Exterior Insulated Finish System (EIFS) was unfinished at the intersection of the wall and roof at one location. The reinforcing mesh is visible over the Expanded Polystyrene insulation. There is also a small open gap in the wall covering under the bottom edge of the edge metal.

Description:
View of the
unfinished edge of
the Insulated wall
System. Note:
opening in wall
under bottom edge
of metal fascia.

The area of wall system presently open to the weather should be sealed with proper materials to prevent future water infiltration. Replacement of the shrinking pourable sealant and deteriorated buffer pad under the antenna are not covered by the warranty. All required repair work should be done by a certified applicator in accordance with the written warranty.

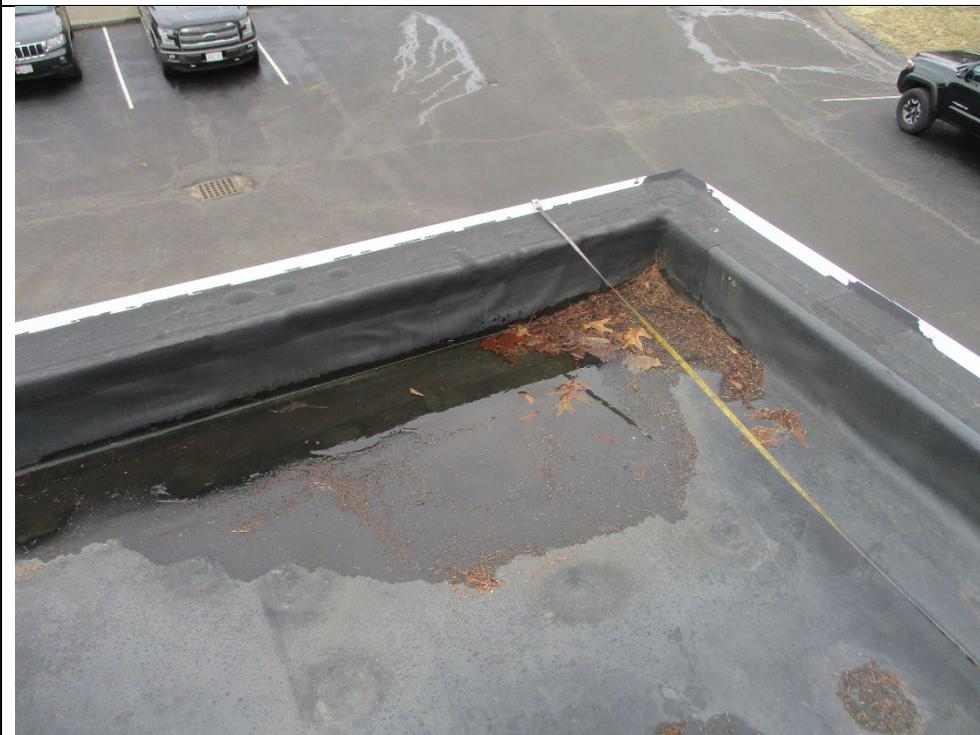
Photo R10
02/17/22

Description:
Accumulation of
pine needles and
other debris in area
of standing water.

The existing roofing systems over the Police Department and low Fire Department roof are in generally good condition at this time. The field seams and field membrane appear to be well adhered to the substrate with no evident delamination. Minor repair work and general maintenance and cleaning of the Police Department roof should allow the roof to reach its typical useful service life of 20+ years. Delaminated and open flashing seams along the low parapet should be covered under the manufacturer’s typical systems warranty. Membrane bubbling and unadhered areas along the low parapet do not appear to be water infiltration issue at this time. This area should be monitored going forward, with repairs being implemented as needed. Cleaning of the roof surface should be considered at least twice a year (spring and fall, or after severe weather events). This should include removal of pine debris and other vegetation on the roof surface and cleaning of the internal roof drain baskets. This work can be undertaken by Town employees.

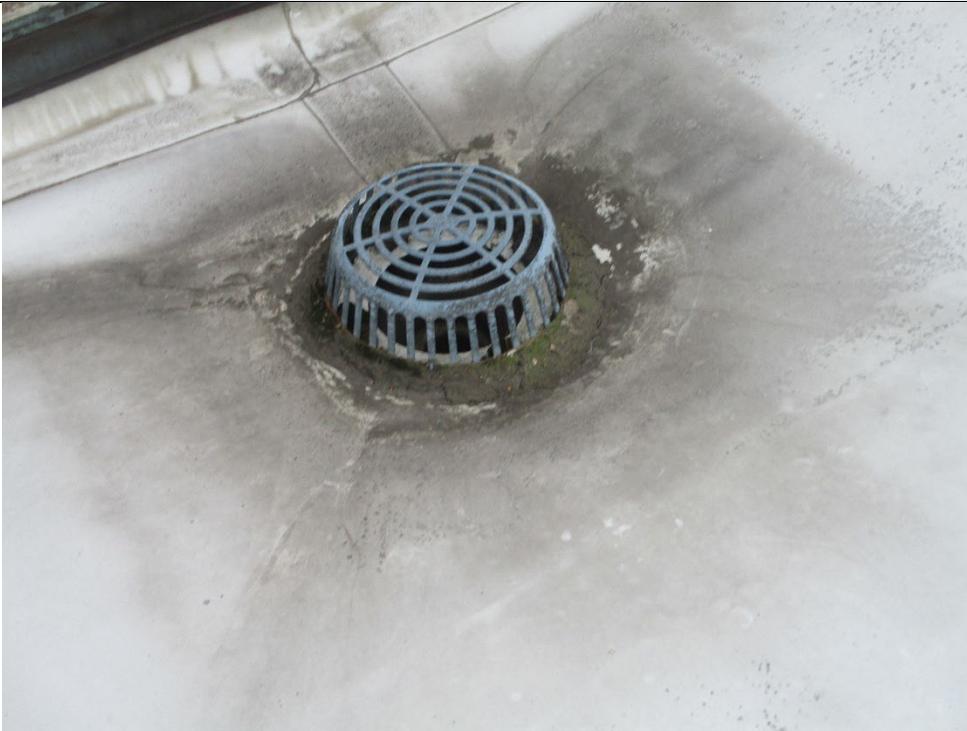
Photo R12
02/17/22

Description:
Accumulation of
debris around
internal roof drain
on TPO roof.

The Fire Department low roof requires no repair work at this time. Cleaning of the drain bowls and roof surface should be done twice a year. Vertical cracks in the masonry wall at the high roof intersection should be routed and sealed with a polyurethane sealant of matching color to prevent water infiltration into the building. The low wall base flashing height should be monitored when snow drifting is occurring as moisture could enter at the top of the through wall flashing joint.
