ROOF ASSESSMENT REPORT

**SHEA THEATER
71 AVENUE A
TURNER FALLS, MA 01376**

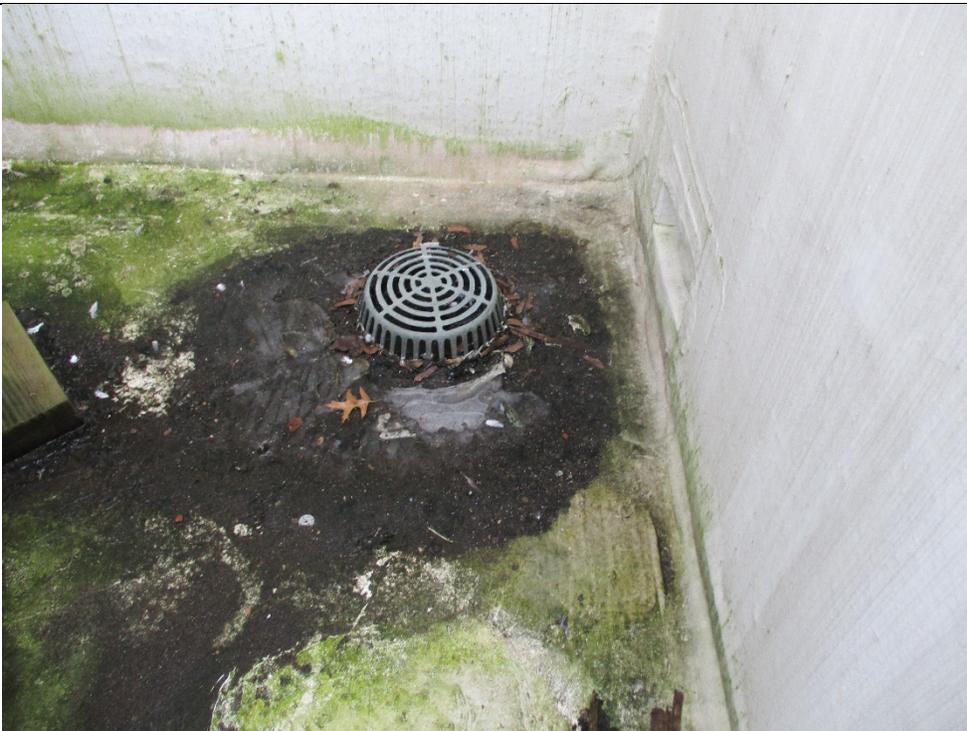
Description:
View of roof termination under window at intersection of Colle Building. (Note narrow work space between wall and mechanical duct would not allow for removal and replacement of roof.)

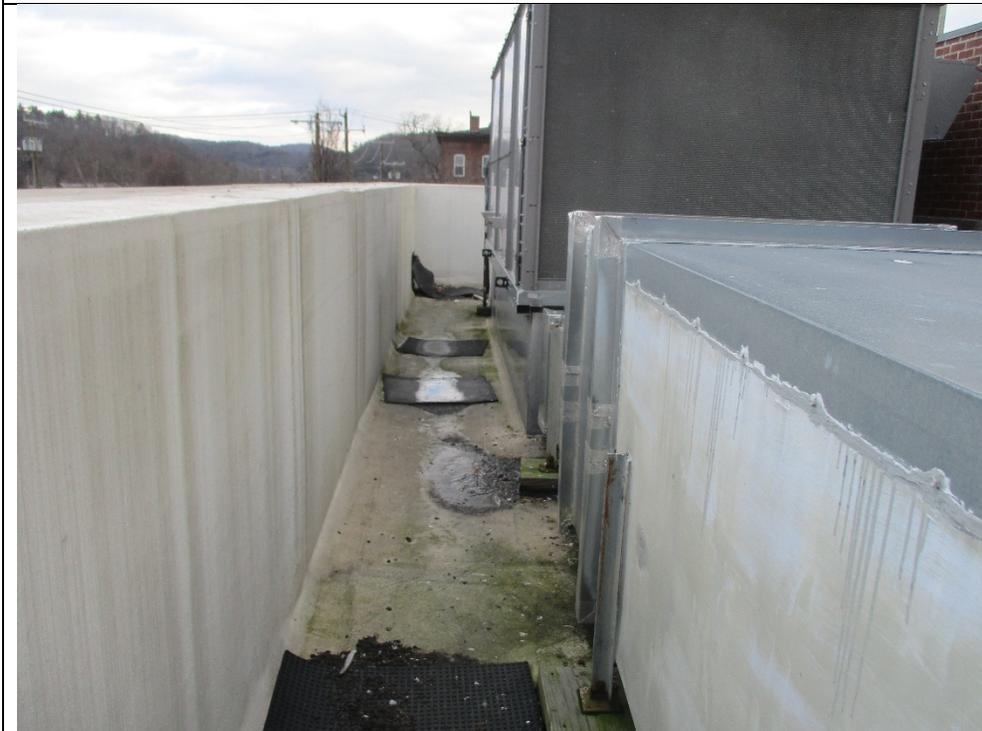
Description:
View of existing ductwork shows little space for removal and replacement of roof system.

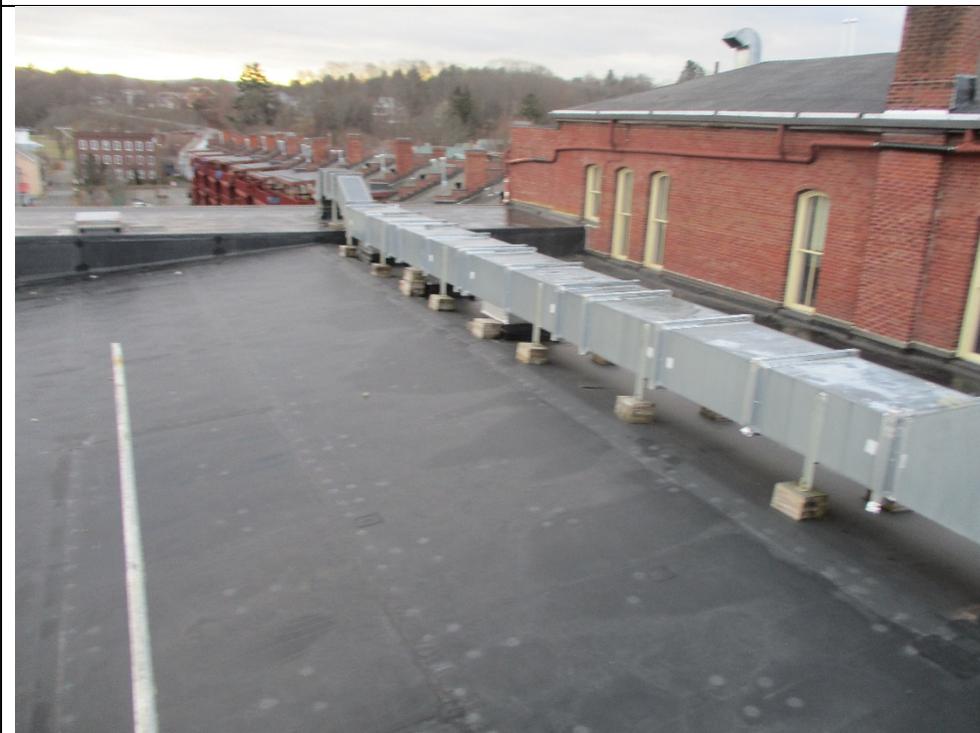
Description:
View of main roof on opposite side of ductwork from Photo R10. Roofing system in good condition with no repairs necessary.
