MONTAGUE CAPITAL IMPROVEMENTS COMMITTEE

Department:	<u>MONTAGUE DPW</u>	Submitted by:	<u>Tom Bergeron</u>
Item/Project Cost:	<u>\$100,000</u>	Date Prepared:	<u>March 15, 2023</u>
Item/Project Title:	<u>11th Street Bridge Repairs</u>

Re: **Eleventh Street Bridge over Utility Canal – Town of Montague, MA**

Weston & Sampson (WSE) has been contracted to perform a limited visual inspection, along with a review of existing documents, MassDOT inspection reports to provide the Town of Montague an engineering evaluation of the condition of Bridge M-28-017 of Montague, MA; which is a Multi-thru Truss Bridge carrying Eleventh Street over Utility Canal.

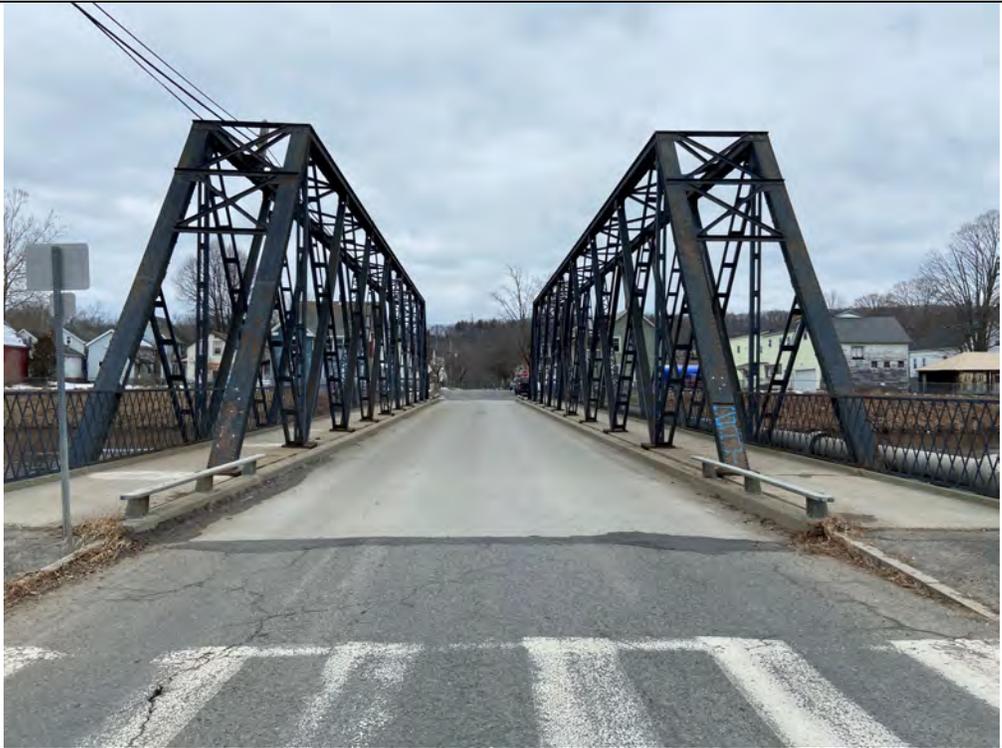
<p>Photo 1</p>	<p>Date: 2/06/23</p>
<p>Description: East Approach of Bridge (looking East)</p> <p>Note: Overhead utilities on South side of bridge, cantilevered utility gas main on North side of bridge, Raveling and cracks at asphalt approach with vegetation growth along approach curbing</p>

Long term repairs should occur within the next five years to assure longevity of the bridge which includes sandblast and painting of the superstructure; milling and paving of the vehicle approaches, bridge roadway and the sidewalk approaches. Resetting sidewalk curbs as required to ensure no difference in elevation for safety concerns. Sounding of the bridge roadway and sidewalk deck should be performed to determine if there is no hollow areas or other concrete issues on the underside of deck. Additional superstructure steel repairs will be required during the sandblasting and painting process due to advanced section losses that can be found and were documented in the MassDOT inspection report.

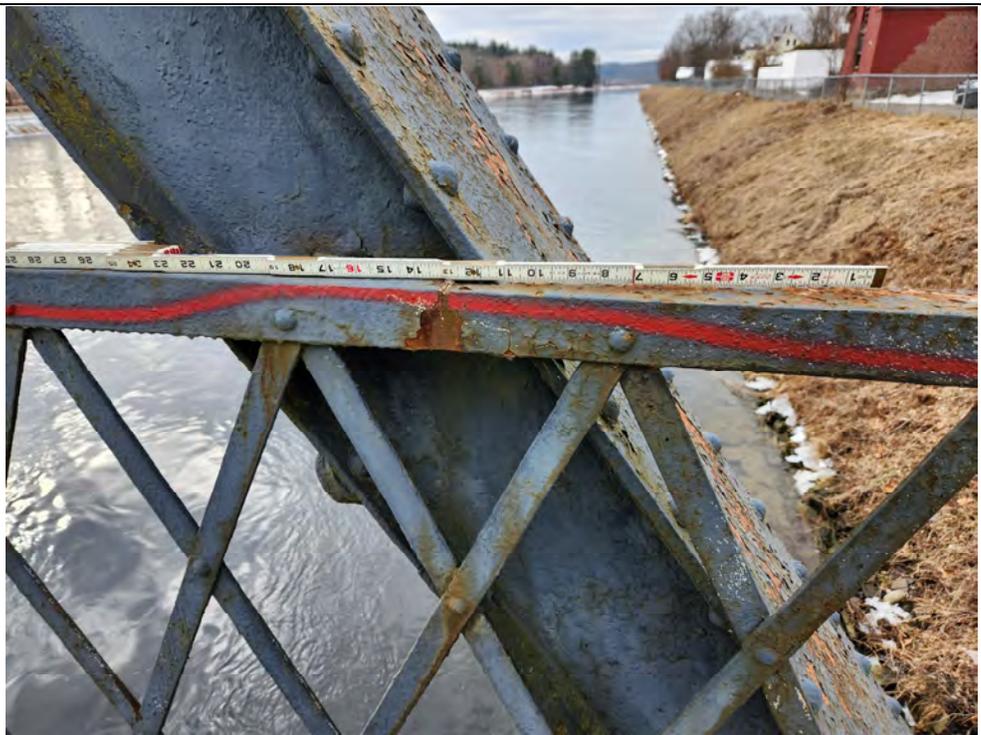
<p>Photo 2</p>	<p>Date: 2/6/23</p>
<p>Description: North Truss (outer) (east end) upper rail (looking North)</p> <p>Note: Cutout of top rail around truss diagonal, crack at top rail, peeling paint, surface rust</p>

Short term repairs should include steel repairs to address existing damages at the handrails system, concrete patches to address spalls throughout the superstructure sidewalks and the concrete piers, replacement of missing and damaged bolts along the handrail system, replace sheared or damaged bolt within the Truss system, replace

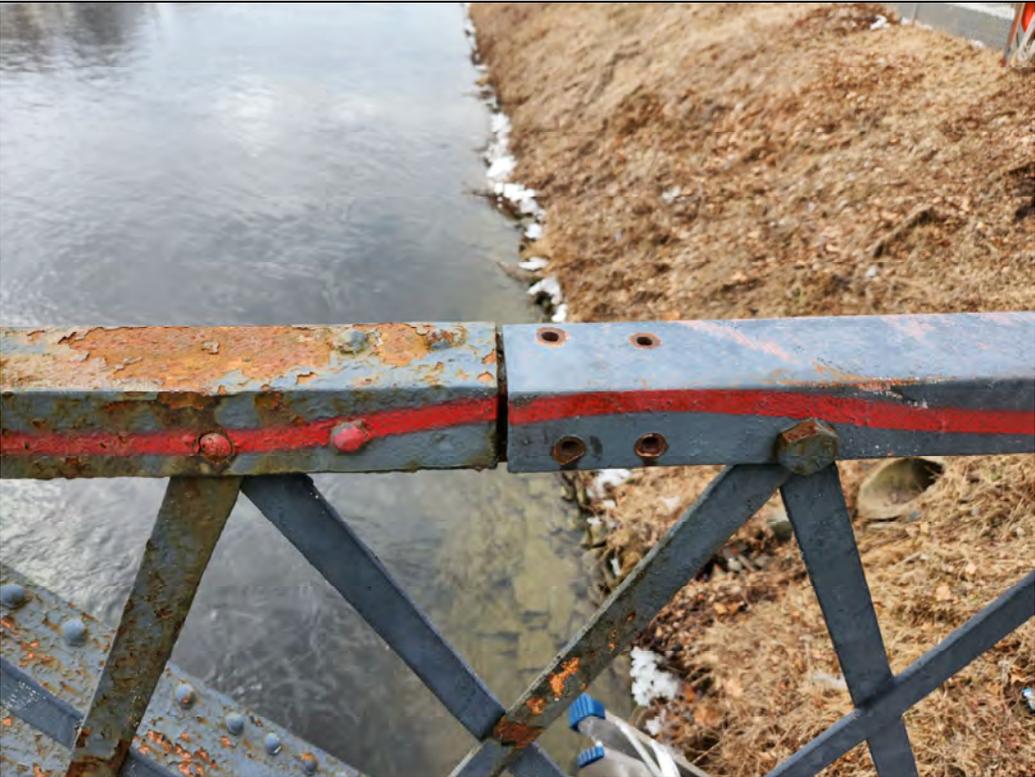
<p>Photo 3</p>	<p>Date: 2/6/23</p>

<p>Description: South Truss (outer) west end handrail upper rail. Note: missing bolts at top rail, peeling paint, surface rust</p>

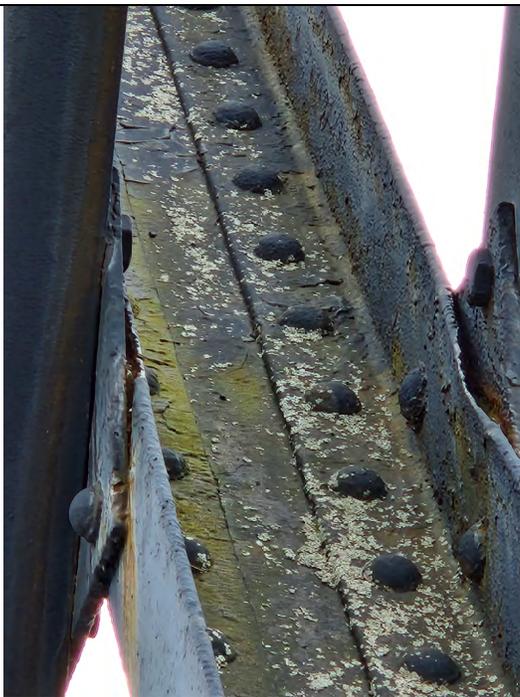
<p>Photo 4</p>	<p>Date: 2/6/23</p>

<p>Description: Outer North Truss Mid Bracing of diagonals @ diagonal flange angle Note: Section Loss and pack rust at angle at mid-connection at diagonal, peeling paint</p>

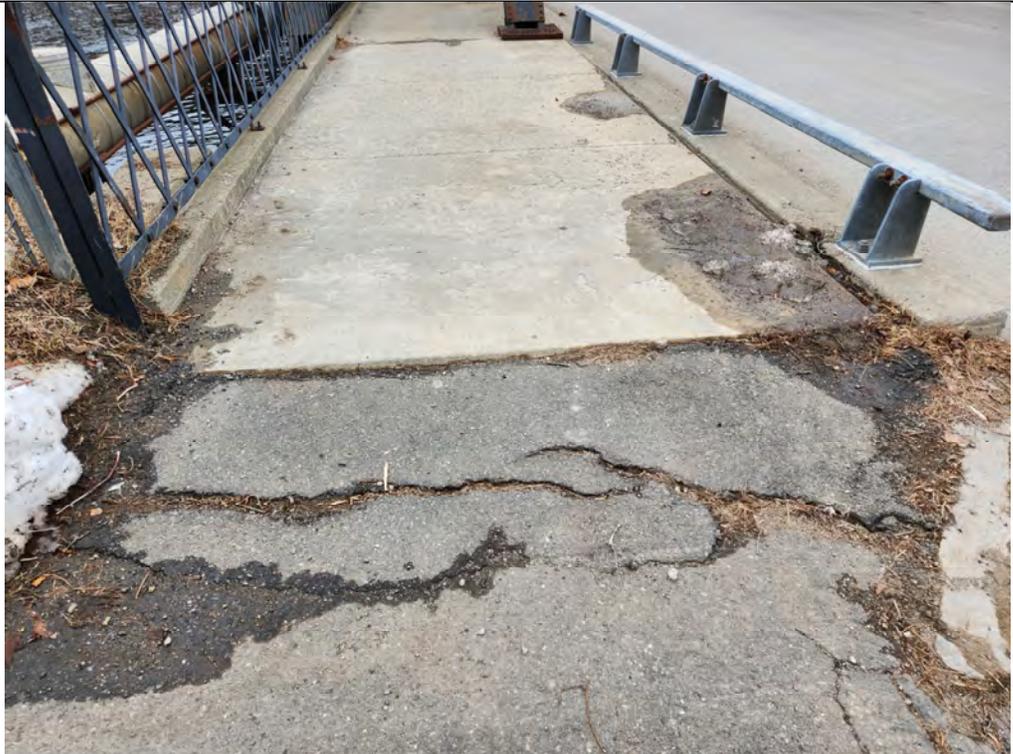
<p>Photo 5</p>	<p>Date: 2/6/23</p>
<p>Description: North sidewalk approach (west side) Note: Up to 1/2" difference in elevation between bituminous approach walkway and bridge sidewalk, cracking and patching of existing asphalt</p>

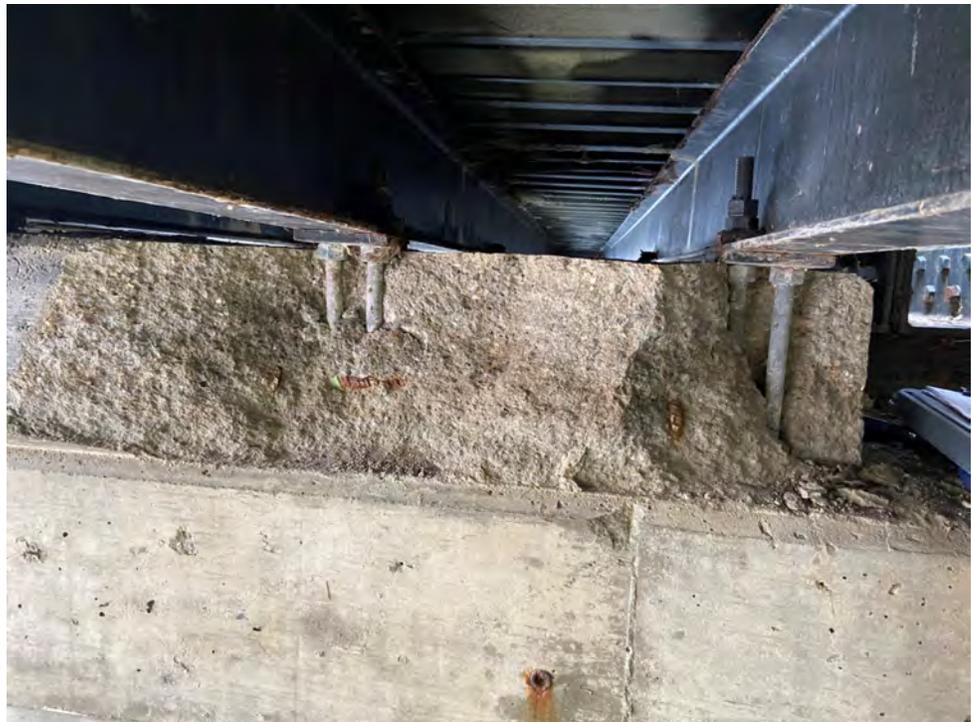
<p>Photo 6</p>	<p>Date: 2/6/23</p>
<p>Description: West Pier North side spall at Interior Stringer 3 and 4 Note: spalled concrete, exposed and rusted rebar, deformed anchor bolts</p>

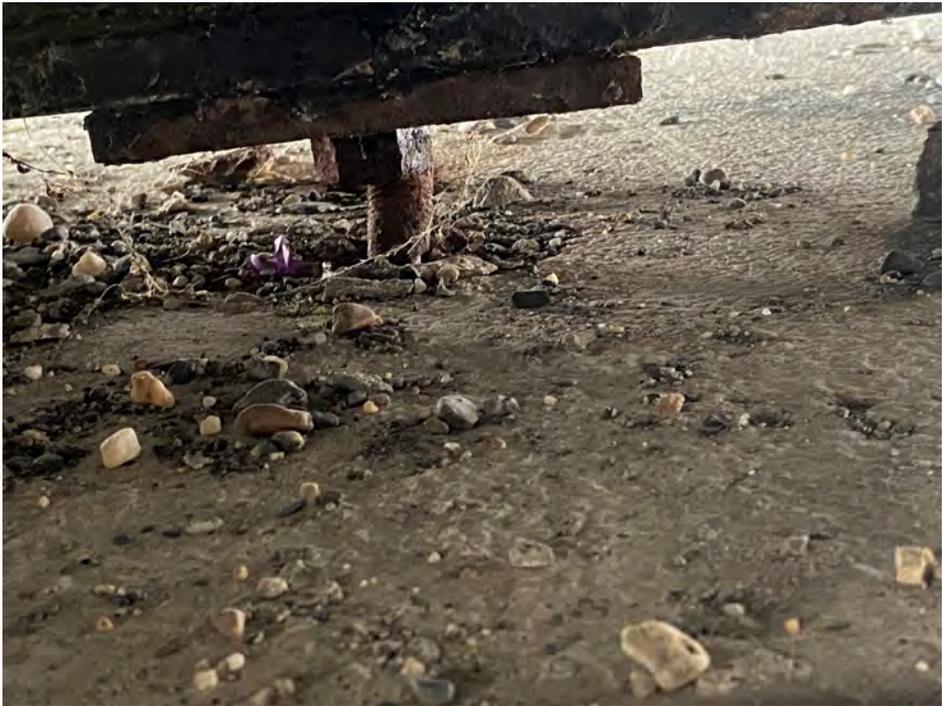
<p>Photo 7</p>	<p>Date: 2/6/23</p>

<p>Description: West Pier North side at Floor beam seat</p> <p>Note: Anchor bolt is sheared and there is no positive connection between floor beam and substructure</p>
---------------------------	--------------------------------	--

damaged bolts at the connection between floor beam and stringer connection plate and repairs to sheared anchor bolts at West Pier's Floor beam.

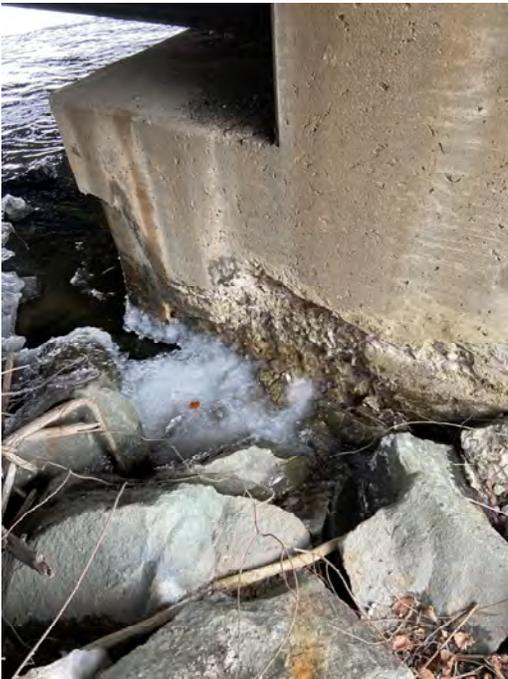
<p>Photo 8</p>	<p>Date: 2/6/23</p>

<p>Description: West Pier South side of column</p> <p>Note: concrete spalls, concrete patch to substructure corner and existing riprap</p>
---------------------------	--------------------------------	--

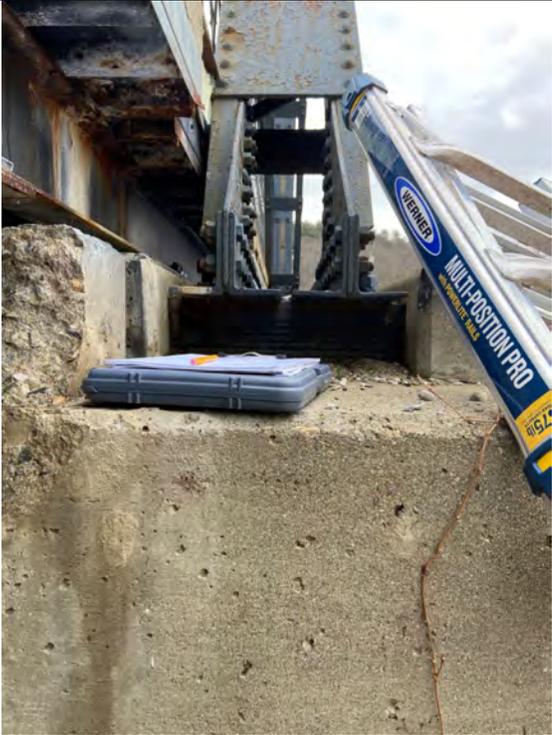
<p>Photo 9</p>	<p>Date: 2/6/23</p>

<p>Description: West Pier Southside of Column Exterior Truss at Elastomeric Bearing</p> <p>Note: concrete spall, rust and peeling paint on the superstructure and stringers, rusting SIP forms.</p>
---------------------------	--------------------------------	--

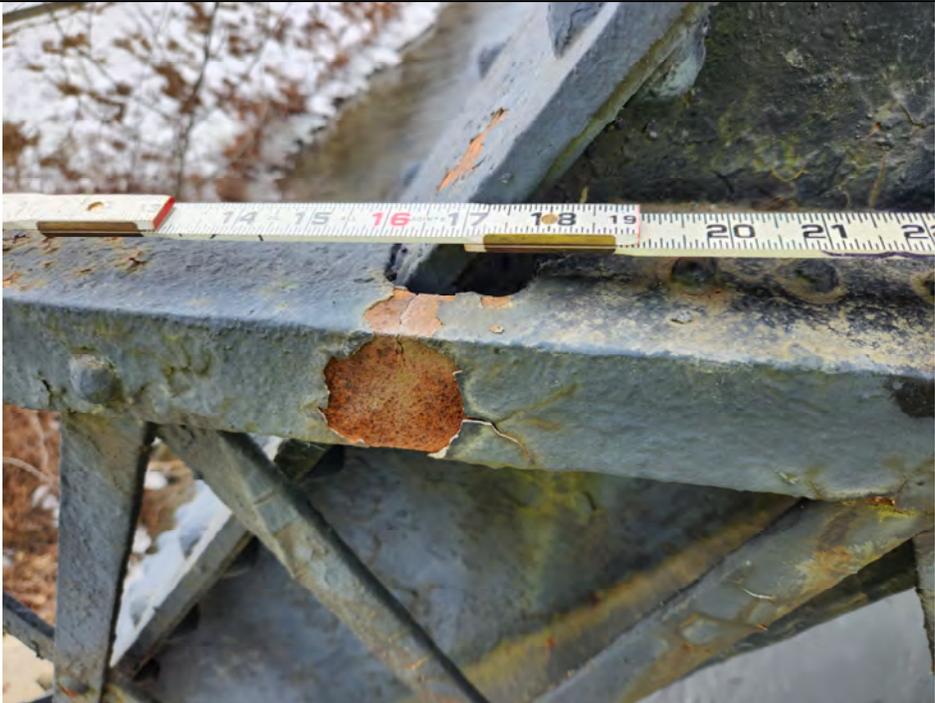
<p>Photo 10</p>	<p>Date: 2/6/23</p>

<p>Description: South Truss (outer) handrail (upper rail) (looking South) (East Side)</p> <p>Note: crack at rail at cutout around truss, rust and peeling paint</p>
----------------------------	--------------------------------	---
