## Article 2: Town Hall and Town Hall Annex Roof Replacement and Repair Request for Appropriation February 19, 2019

### Selectboard's Request

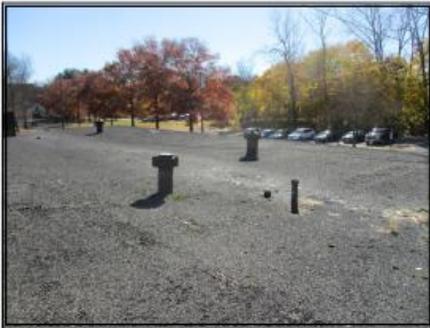
Photo R17 — Overview of garage/office roof at Town Hall Annex.
